Hydrologic Evaluation of the Pelican Lake (69-841) Dam

St. Louis County

February 10, 2009

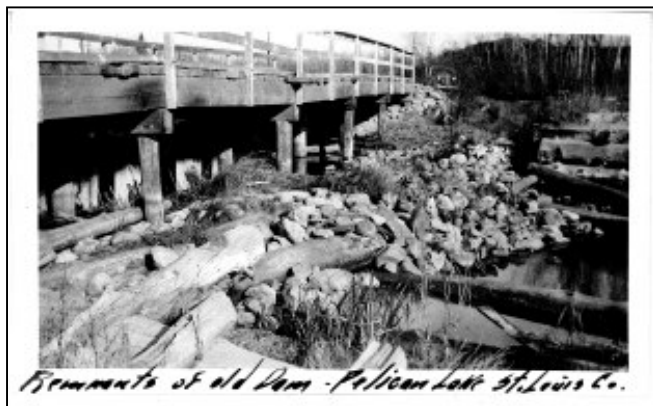
Figure 1. Original rock and brush dam

An outlet dam located at St. Louis County Highway 23 controls lake levels on Pelican Lake. The earliest report of a dam was by the county highway engineer who reported that, circa 1918-23, a "rock and brush dam [had been] constructed by timber operators or local residents for purpose of holding the lake level at a higher stage during dry periods. Some time prior to construction of the 1938 bridge and dam, the old timber dam had deteriorated to such an extent that it no longer was effective. Boats negotiated from the river out into the lake over this old dam without difficulty."

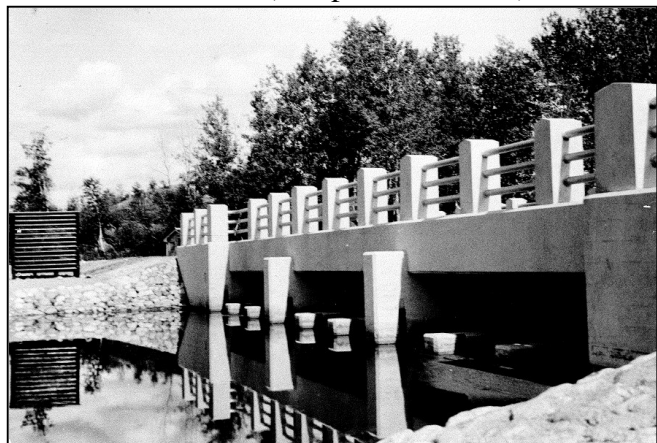
Figure 3. Pelican Lake dam shortly after construction

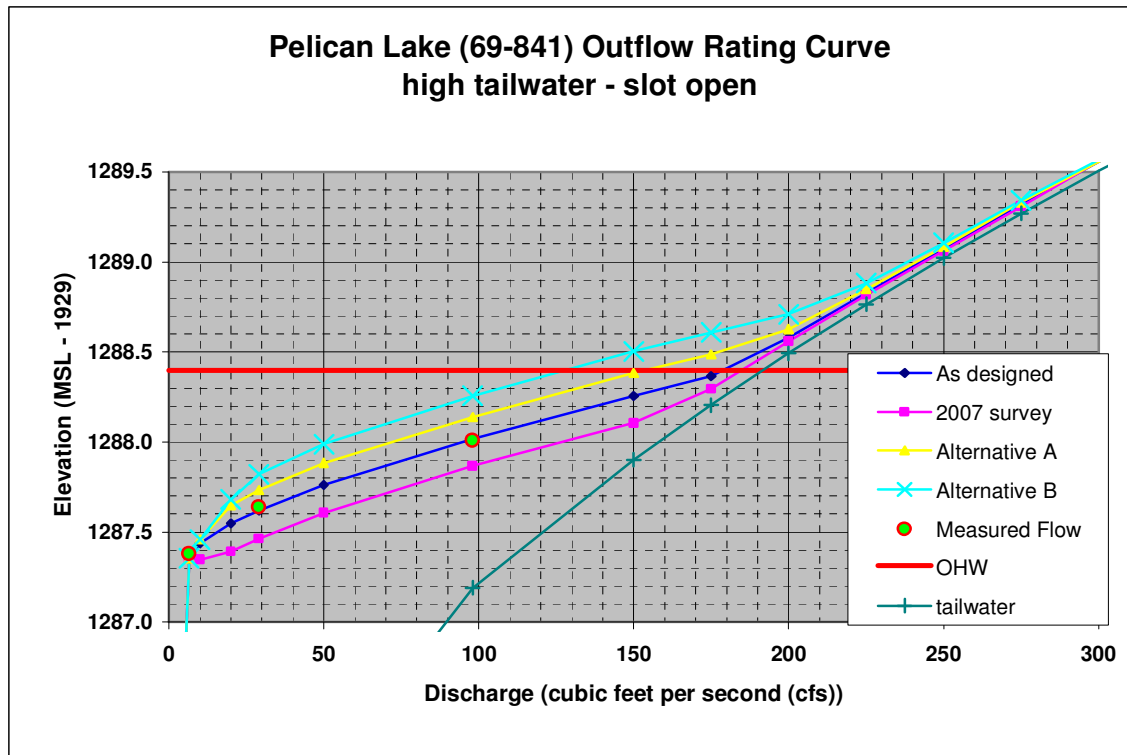
Figure 6b. Outflow rating curves – high tailwater conditions and slot assumed open

Lake dam, i.e., outflow is not impacted (Figure 6a). Outflow rating curves were also developed assuming higher tailwater conditions (Figure 6b). Both sets of curves were used in the subsequent lake water budget analysis. Separate sets of curves were also developed based on whether the 10" x 12" slot in the center weir was assumed open or closed.
